R22

SERVICE BULLETIN #71

DATE: 18 June 1992

SUBJECT: Inspection of Upper V-Belt Sheave

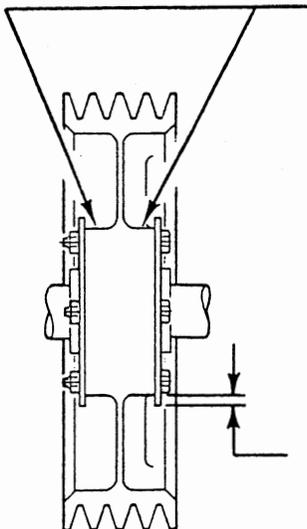
Upper Sheave

BACKGROUND: In 1990 the A170 Sheave material was changed from a casting to a machined part. The change included some dimensional modifications, one of which, was a reduction in the flange thickness from approximately .28 to .20 inches. Despite the higher strength of the machined material, there have been two reported cases of cracks developing in the thinner flange. The flange thickness was increased to .30 inches for all A170-1 and -2 Rev K and later Sheaves.

Flanges to be checked for crack indications (all around).

If this depth is greater than .30 inches, a Rev I or J Sheave is installed and this Service Bulletin applies.

Use a strong light and look for any indications of a crack starting at the edges of the flanges next to the seal retaining plates. Rotate the drive system so you can observe the complete circumferences of the flanges. If any crack indications are found, dye penetrant inspect the suspect area. If it is a crack, ground the aircraft until the sheave is replaced.
