R22

SERVICE LETTER SL-55

SUBJECT: Main Rotor Blade Inspection

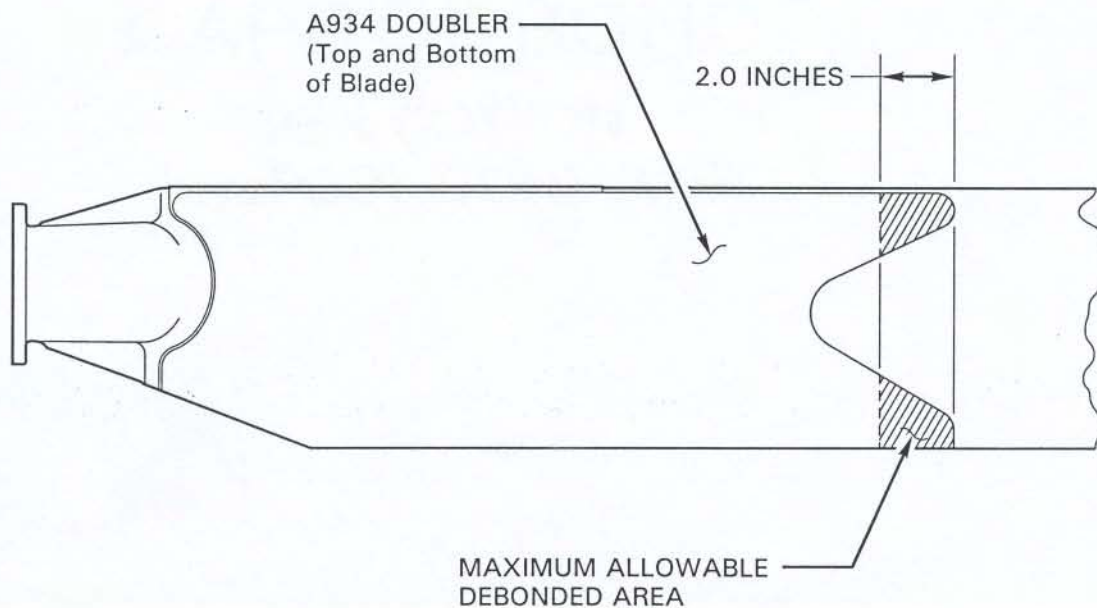
A016-4 MAIN ROTOR BLADE DEBOND LIMITS

BACKGROUND: RHC has received reports of debonding at the tips of A934 doublers on A016-4 main rotor blades. While not an immediate airworthiness issue, inspection every 100 hours is warranted.

1. During each 100-hour inspection, tap test outboard tips of A934 doublers (top and bottom of blade) as indicated in figure below.
2. If debond area exceeds limits, remove rotor blade from service and inform RHC Technical Support of blade serial number and time in service.
