R44

SERVICE LETTER #10

SUBJECT: C439-7 Guide Assembly

ROTORCRAFT AFFECTED: All R44 Helicopters

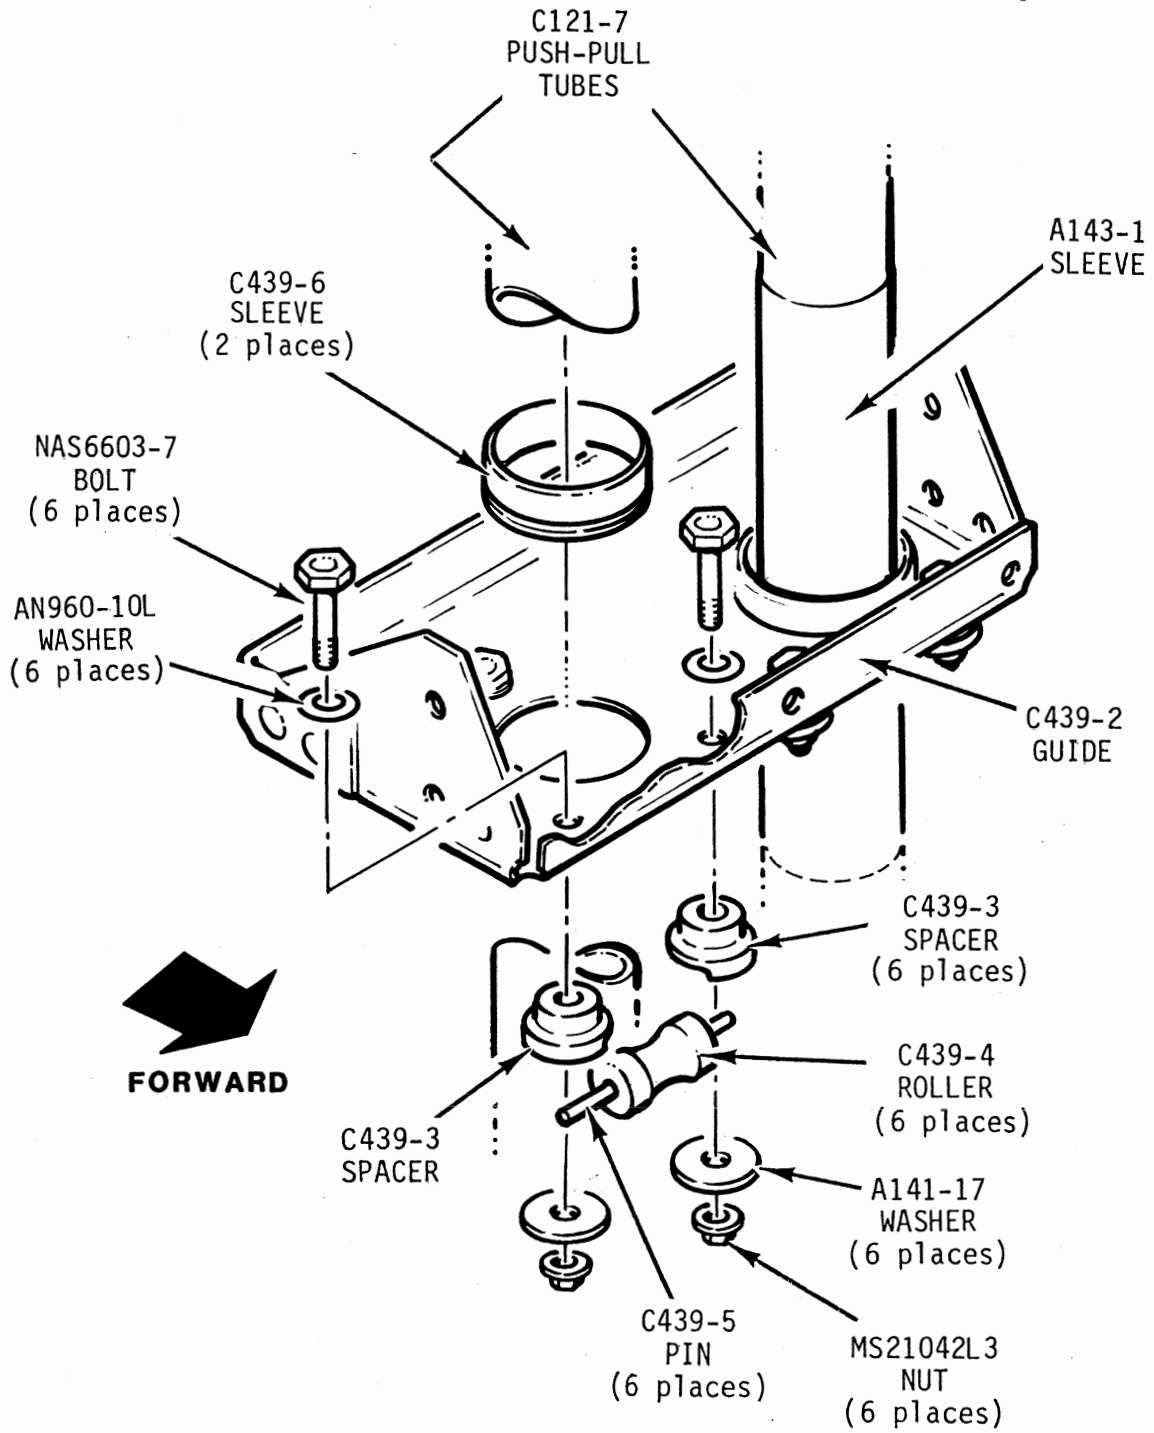
C439-7
GUIDE ASSEMBLY

BACKGROUND: During a 2000-hour overhaul inspection RHC has found a C439-7 guide assembly with two abnormally-worn C439-4 rollers and elongated holes in the C439-2 guide which hold the C439-6 sleeves. RHC has received one similar report from the field which also included a damaged A143-1 sleeve. Refer to illustration on page 2.

- 1) During any maintenance procedure when guide is exposed and at each 100-hour inspection, inspect C439-4 rollers for abnormal wear, inspect A143-1 sleeves for damage, and inspect C439-6 sleeves for excessive looseness due to elongated mounting holes in C439-2 guide.
- 2) Replace worn rollers and damaged A143-1 sleeves; refer to R44 Maintenance Manual section 8.162 if C121-7 push-pull tube is damaged. If elongated holes are found in C439-2 guide notify RHC Technical Support of affected ship s/n and part total time in service.
