R22 SERVICE LETTER SL-58

R44 SERVICE LETTER SL-38

R66 SERVICE LETTER SL-01

SUBJECT: Cracked MS21042L-series Nuts

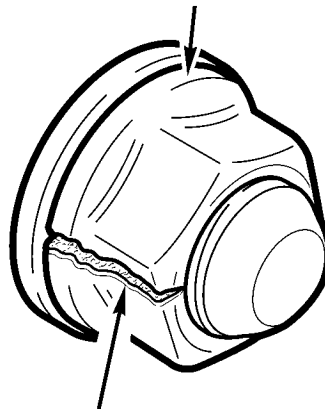
MS21042L-series Nut

BACKGROUND: RHC has received two reports of cracked MS21042L4 self-locking nuts. Other helicopter manufacturers have received similar reports. A possible cause for cracking nuts is hydrogen embrittlement, which can be introduced during hardware manufacturing. Manufacturing processes for government- and industry-standard hardware are not controlled by RHC.

Any crack, if present, would be parallel with nut axis.

Pilots and maintenance personnel are reminded that hardware condition is equally important as hardware security. Cracked or corroded nuts require replacement.

Contact RHC Technical Support at techsupport@robinsheli.com if cracked nuts are found.
