R22 SERVICE BULLETIN SB-112

R44 SERVICE BULLETIN SB-94

DATE: 8 June 2017

SUBJECT: Actuator Lower Bearing A185 Brackets

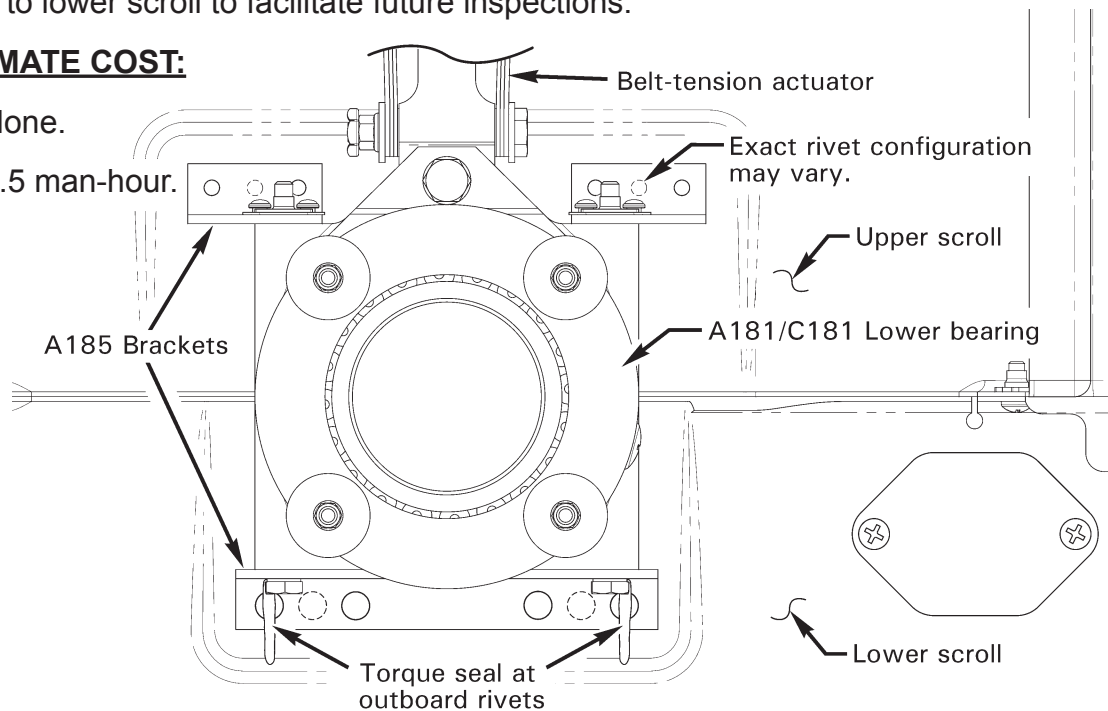
View looking aft

BACKGROUND: RHC has received reports of loose A185 brackets. Loose brackets may have allowed lower bearings to misalign resulting in belt-tension actuator damage.

1. Visually inspect A185 brackets and attaching rivets for evidence of fretting or looseness. If evidence of looseness is found, contact RHC Technical Support for repair instructions.
2. On lower A185 bracket, apply torque seal in a vertical stripe across both outboard rivets to lower scroll to facilitate future inspections.
