R22 SERVICE LETTER SL-92

R44 SERVICE LETTER SL-81

R66 SERVICE LETTER SL-39

SUBJECT: ELT Security

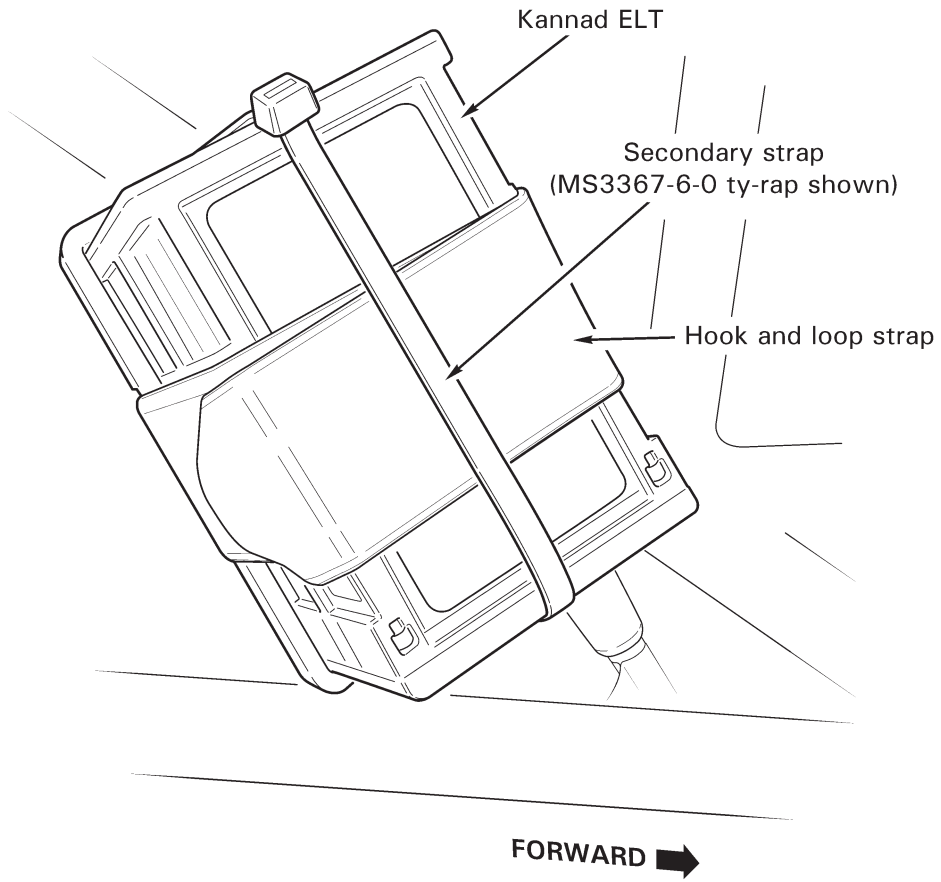
BACKGROUND: RHC received a report of an ELT hook & loop retaining strap failure, which allowed the ELT to fall into the drive train.

Early R22 and R44 Kannad ELT installations did not include a secondary strap and should be upgraded. Refer to figure on page 2.

During periodic inspections, maintenance personnel should verify the ELT is properly seated in the mounting bracket and the hook & loop strap has no slack or deterioration.

The hook & loop strap and mounting bracket may deteriorate over time and should be replaced if damage is noted, or every 12 years, whichever occurs first. A Kannad P/N S1840502-01 kit (available from RHC Customer Service) includes a mounting bracket and hook & loop strap.

Ensure a secondary strap is installed. Acceptable secondary straps are:

- B359-2 Releasable ty-rap (installed at RHC factory circa 2008 – 2011)
- D693-4 Strap (installed at RHC factory circa 2011 – 2021)
- MS3367-6-0 Ty-rap (current production)
