R22 SERVICE LETTER SL-93A

R44 SERVICE LETTER SL-82A

R66 SERVICE LETTER SL-40A

SUBJECT: Tail Rotor Blade Condition and Care

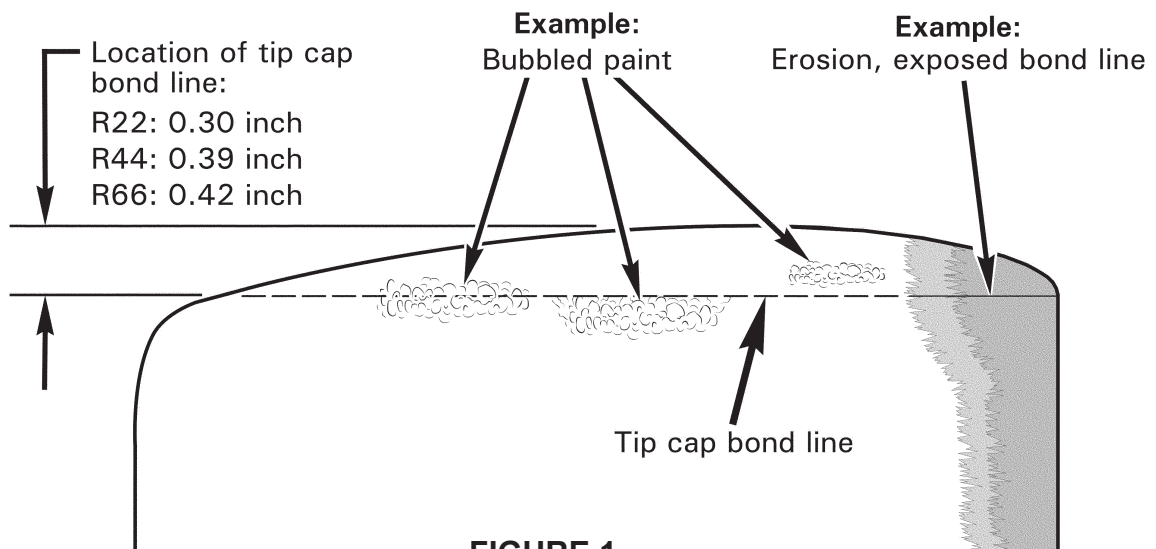
FIGURE 1

1. Inspect tail rotor blade leading edges & tip cap bond line carefully during daily preflight. Refer to Figure 1.

Bubbled paint can be an indication of underlying corrosion. If bubbled paint is observed at or adjacent to tip cap bond line, or if bond line is exposed, perform following maintenance prior to further flight.

At, or adjacent to, tip cap bond line: Remove loose or bubbled paint with fingernail or plastic scraper. Using minimum 10X magnification, examine bond line for both presence of adhesive & no corrosion (white powder and/or pitting). Metal-to-metal contact of tip cap to skin is permissible, but any gaps in remaining bond line due to missing blue (or brown) adhesive requires blade replacement. Any evidence of corrosion at bond line requires blade replacement. If blade(s) require replacement, contact RHC Technical Support with part number & serial number of affected and opposite blades.

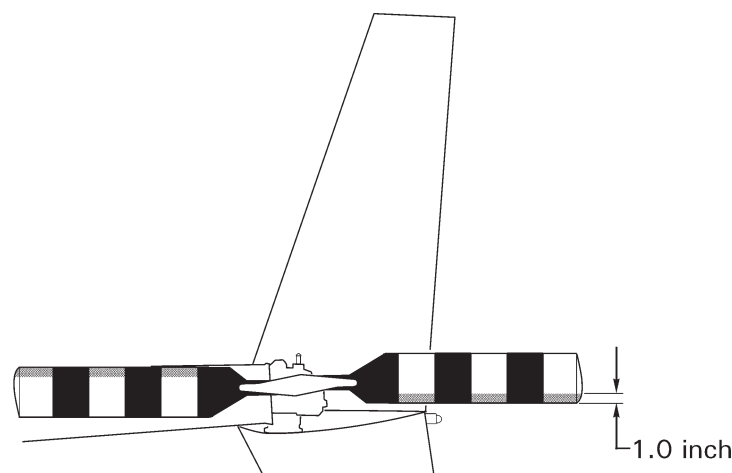
FIGURE 2

Preferred blade condition is with fully painted leading edge. Use two coats of Desoprime CA7502 epoxy primer (or equivalent). Scuff primer prior to applying second coat. Use Dupont Imron polyurethane enamel or equivalent paint. Refer to aircraft Maintenance Manual (MM) for specific paint codes. Blades with striped leading edges may be painted with solid black leading edge as shown in Figure 2 if desired for ease of application:

Paint offers the best protection against leading edge corrosion. If painting blades is impractical, apply at least a single coat of primer on tip cap bond lines and on leading edges to provide some protection.

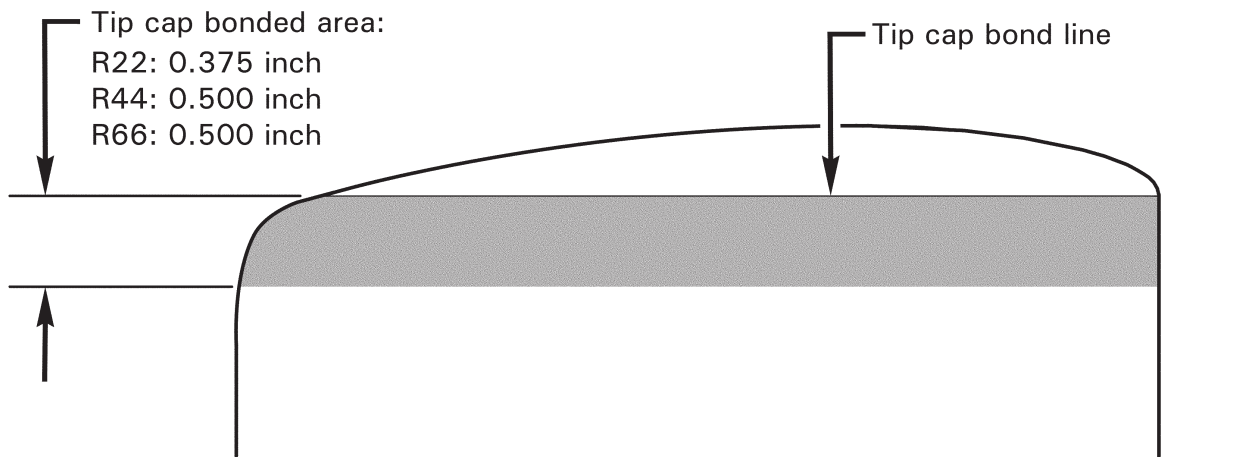
FIGURE 3

3. Balance tail rotor per applicable MM after any corrosion removal or painting.
4. When operating in a corrosive environment, clean tail rotor daily per POH section 8, Cleaning Helicopter (mild soap means a pH between 7 & 9). If waxing blades is impractical, wipe blade leading edges with standard WD-40® brand light oil or equivalent; do not use ACF-50® lubricant or “Specialist” versions of WD-40® on blades, and do not use Salt-Away®.
5. At each 100-hour inspection, tap test tip cap bonded area shown in Figure 3 to verify bond integrity. Reference tap test instructional video at: https://robinsonheli.com/wp-content/uploads/2021/06/taptest_05_apr_2010.mp4
