## **SAFETY ALERT**

### **CORROSION AT TAIL ROTOR BLADE TIPS**

For all R22, R44, and R66 series helicopters:

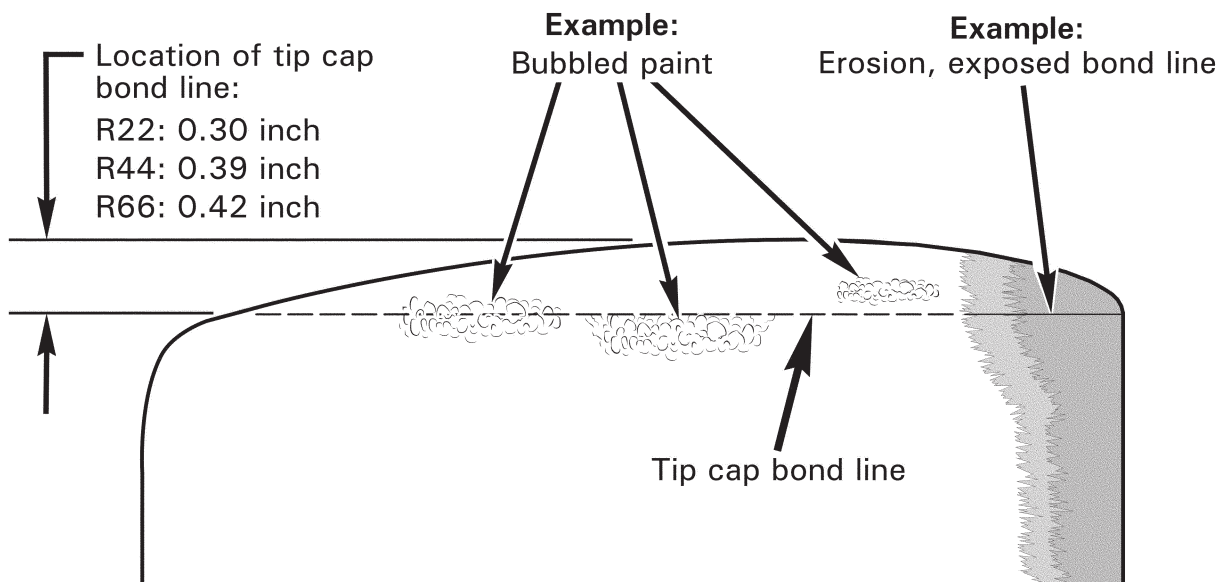
The aerodynamic tips of the tail rotor blades are bonded in place. Any corrosion in the bond area can damage the bond. If allowed to progress, corrosion can weaken the bond enough to cause a tip to come loose and be ejected. The most corrosive environment is salt air. Helicopters conducting oceangoing shipboard operations or operating near saltwater coastlines are particularly susceptible to corrosion, especially if stored outdoors. An ejected tip can cause enough vibration to result in failure of the tail rotor gearbox housing.

- Refer to figure below. Use extra attention during preflight inspection of tail rotor tip area.
  - Bubbled paint can be an indication of underlying corrosion. If bubbled paint is observed at or adjacent to tip cap bond line, do not fly helicopter. Have maintenance personnel comply with latest revision R22 SL-93/R44 SL-82/R66 SL-40 prior to further flight.
  - If any portion of tip cap bond line is exposed, do not fly helicopter. Have maintenance personnel comply with latest revision R22 SL-93/R44 SL-82/R66 SL-40 prior to further flight.
