ROBINSON HELICOPTER COMPANY

R66 MAINTENANCE MANUAL AND INSTRUCTIONS FOR CONTINUED AIRWORTHINESS RTR 660 VOLUME I

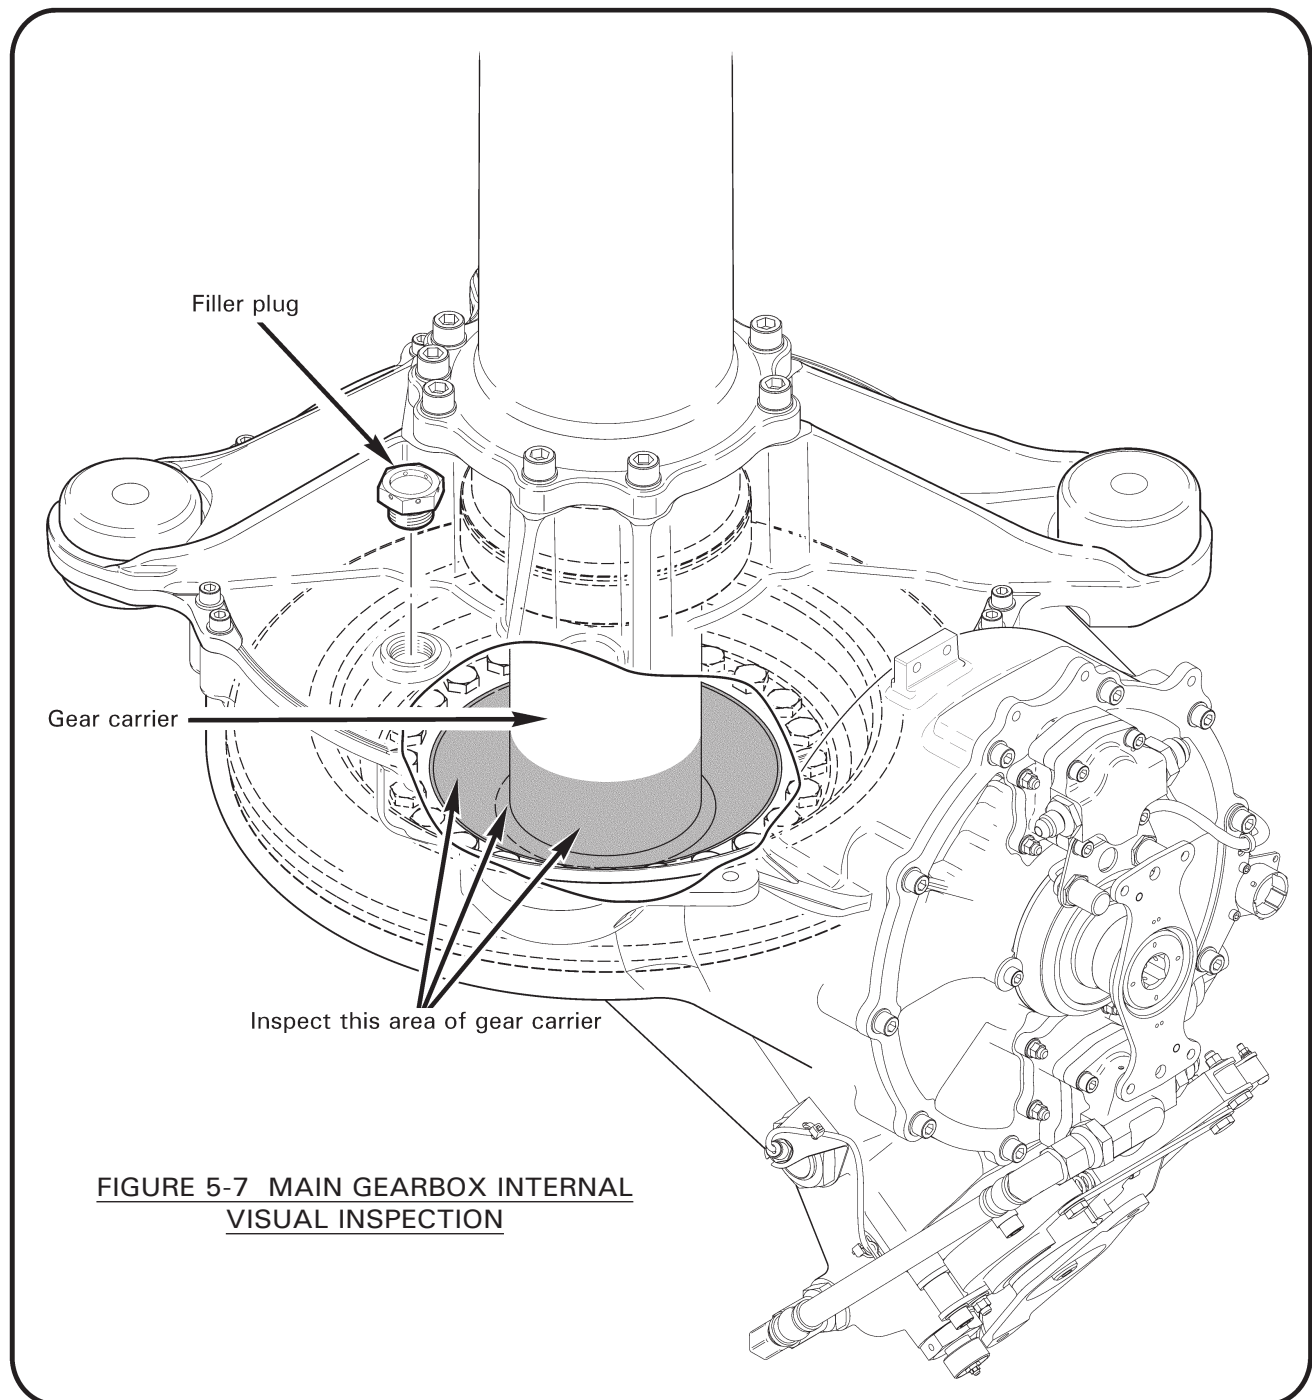
**FIGURE 5-7 MAIN GEARBOX INTERNAL
VISUAL INSPECTION**

1. Refer to Figure 5-7. Gain access to and remove main gearbox filler plug.
2. Via filler plug hole and using borescope, miniature camera, or smartphone camera with flash, visually inspect specified area of gear carrier. Rotate gearbox by hand-turning main or tail rotor as required to view entire circumference.
3. If no corrosion or paint bubbling is evident, install filler plug & special torque per § 20-33.
4. If corrosion or paint bubbling is detected, contact RHC Technical Support.

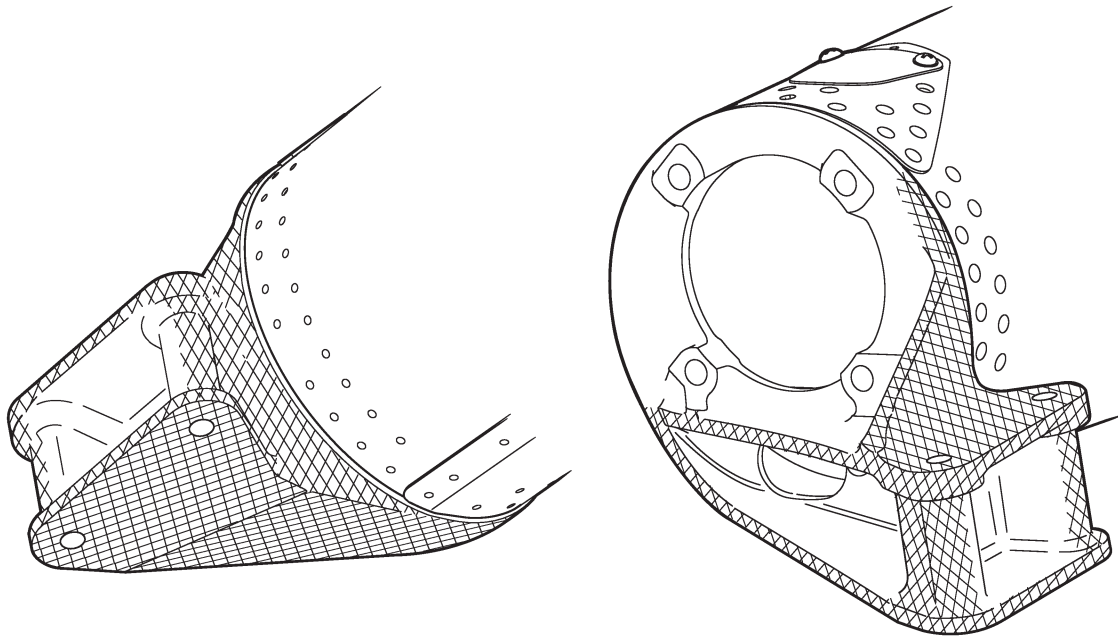
FIGURE 5-8 CROSS-HATCHED SURFACES OF TAILCONE'S AFT BULKHEAD

1. On associated tailcone's aft C148 bulkhead, strip paint from cross-hatched surfaces shown in Figure 5-8 using § 20-71 approved materials.
2. Perform fluorescent penetrant inspection (FPI) per § 20-42 of stripped surfaces. Replace tailcone if crack is indicated.
3. Conversion coat bare aluminum per § 20-51, as required. Epoxy prime (chromated-epoxy primer preferred) & topcoat stripped surfaces per § 20-60.

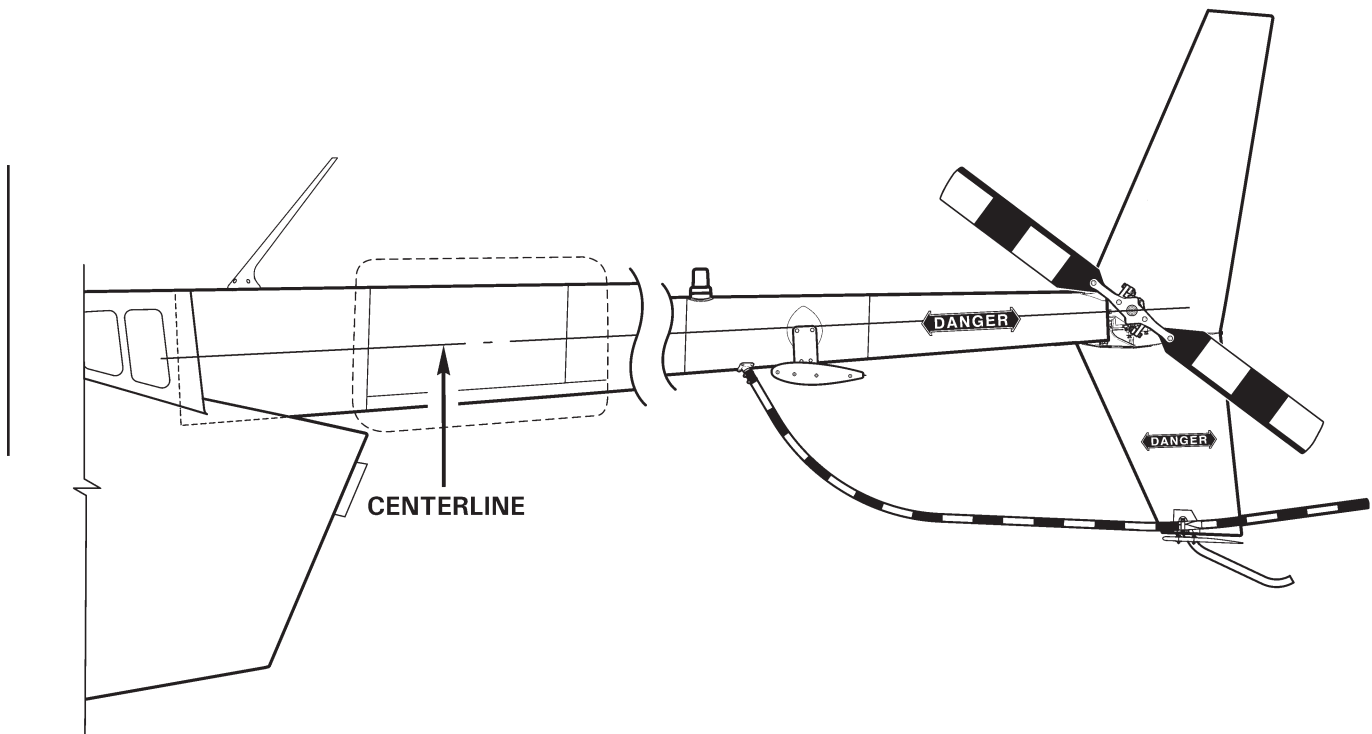
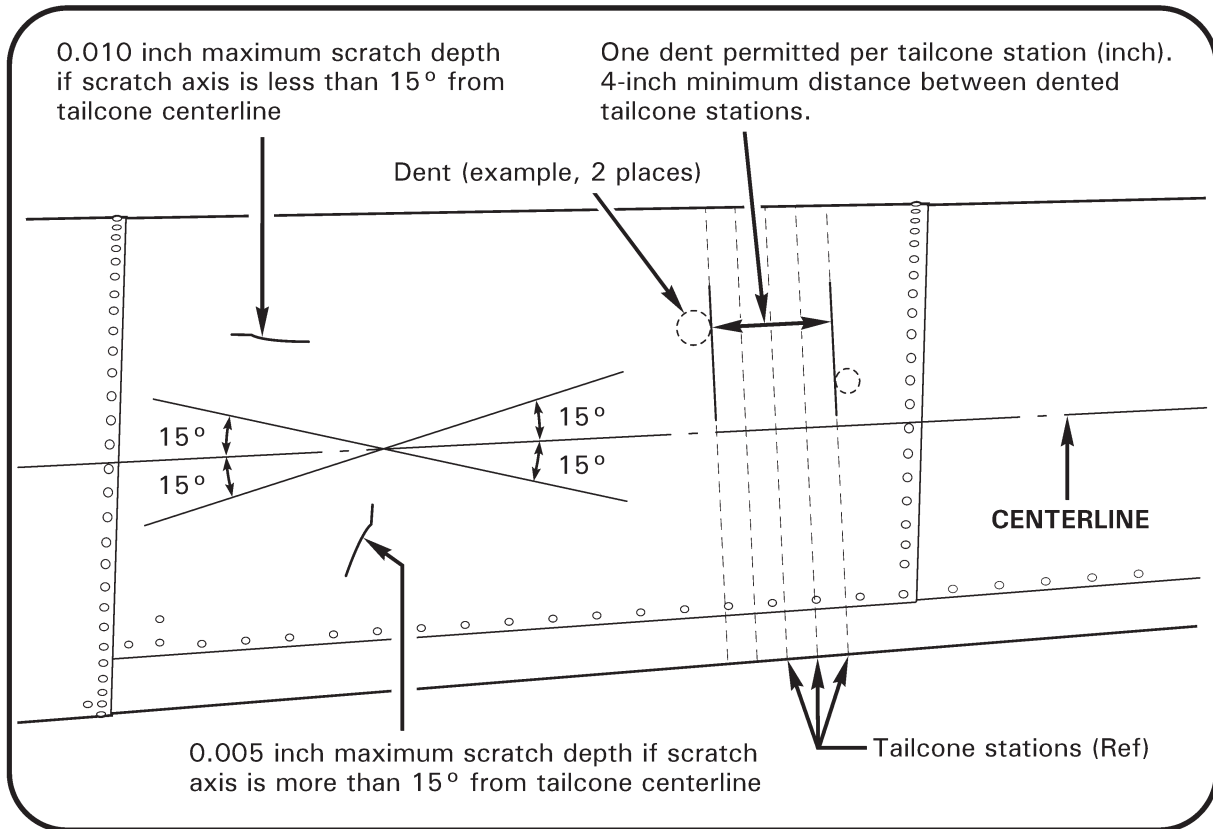
FIGURE 53-5 TAILCONE INSPECTION AND REPAIR

1. Refer to Figure 53-5. Verify damage does not exceed the following limits:
 - a. 0.005 inch maximum scratch depth if scratch axis is more than 15° from tailcone centerline.
 - b. 0.010 inch maximum scratch depth if scratch axis is less than 15° from tailcone centerline.
2. If damage exceeds limits, return tailcone assembly to RHC for repair. If damage is within limits, blend out scratches with a 0.10 inch minimum blend radius. Refinish skins using approved materials per § 20-70.

1. Refer to Figure 53-5. Smooth, round bottom dents with 0.125 inch minimum radius without sharp nicks or cracks are acceptable when damage does not exceed the following limits:
 - a. 0.030 inch maximum dent depth.
 - b. 1.250 inch maximum dent diameter.
 - c. One dent permitted per tailcone station (inch).
 - d. 4.000 inch minimum distance between dented tailcone stations.
2. If damage exceeds limits, replace tailcone or return to RHC for repair.

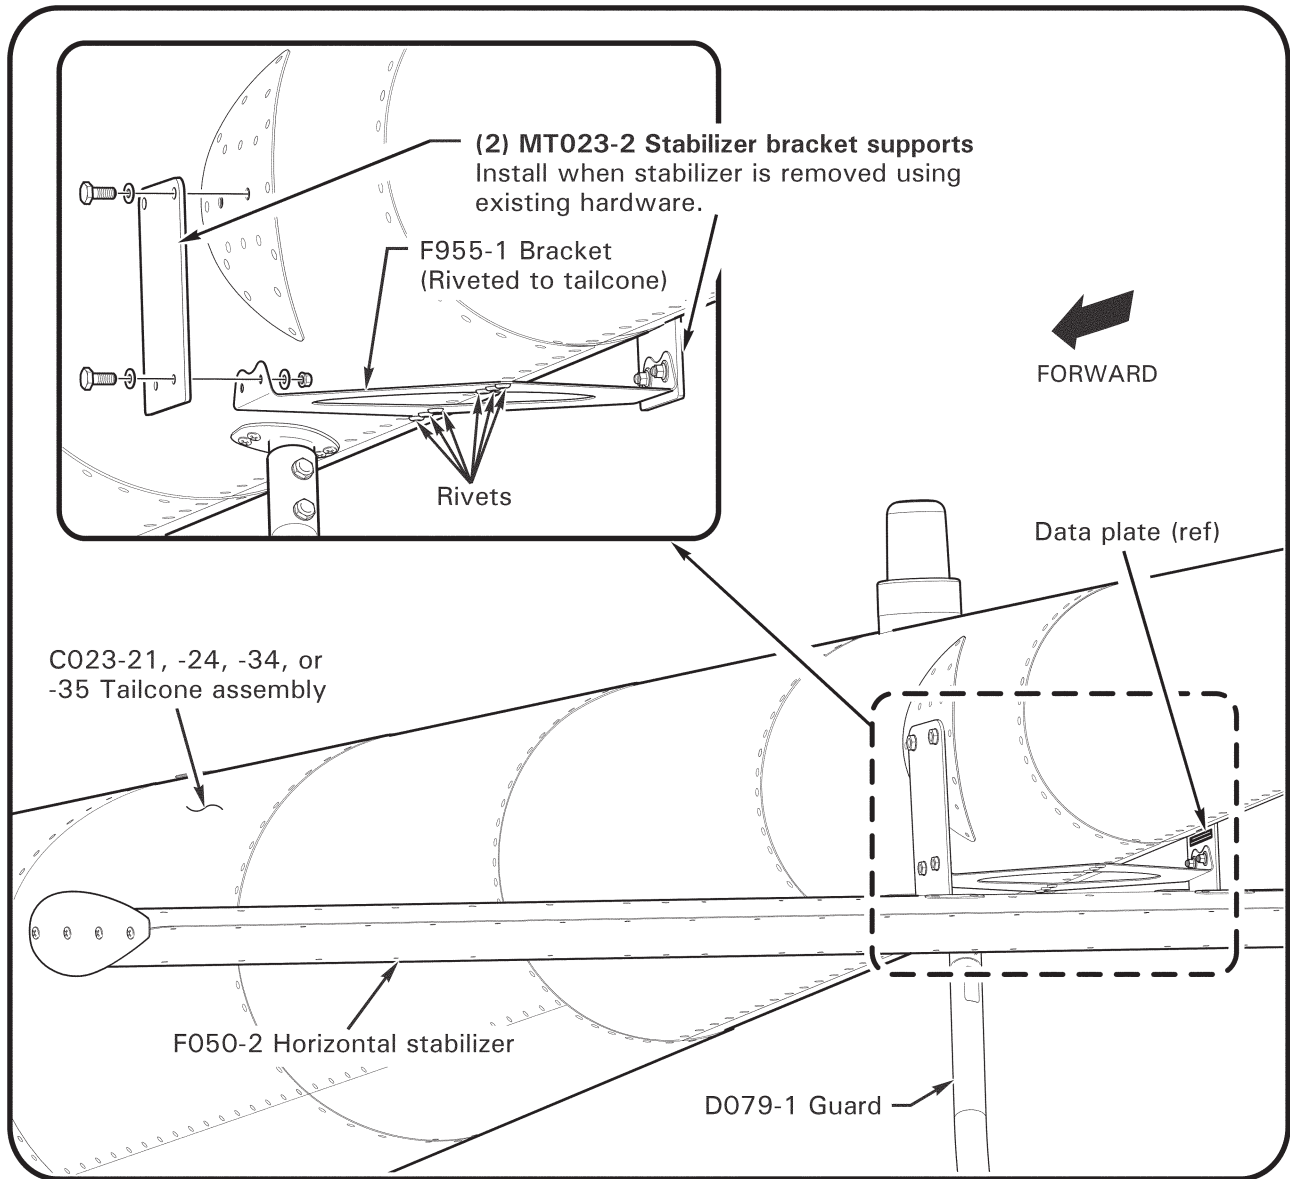
FIGURE 53-6 F050-2 HORIZONTAL STABILIZER ASSEMBLY

1. Refer to Figure 53-6. Remove hardware securing F050-2 horizontal stabilizer assembly to F955-1 bracket.
2. Supporting stabilizer, remove hardware securing stabilizer to tailcone assembly and remove stabilizer.
3. As required, install MT023-2 stabilizer bracket supports using removed hardware (recommended when stabilizer is removed).

1. If installed, remove hardware securing MT023-2 stabilizer bracket supports to F955-1 bracket & tailcone assembly and remove supports.
2. Supporting F050-2 horizontal stabilizer assembly, install hardware securing stabilizer to tailcone and bracket. Special torque bolts per § 20-33 and torque stripe per Figure 5-1.

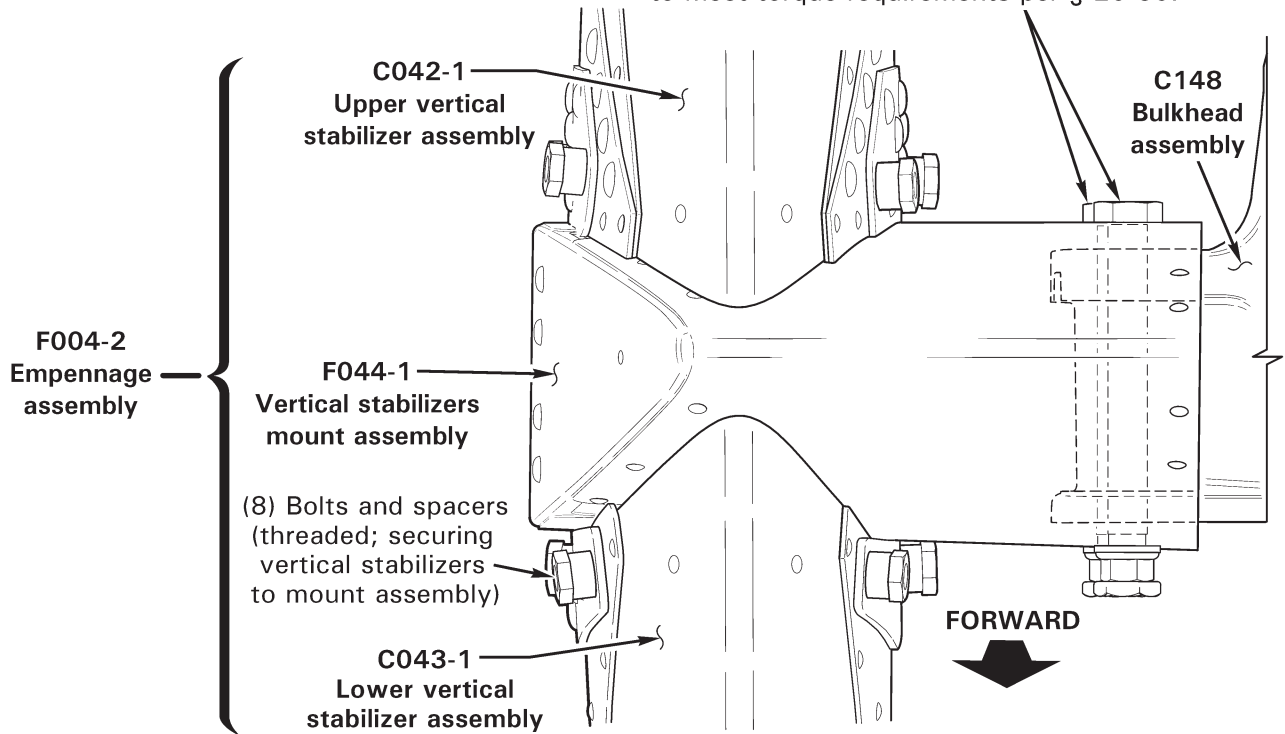
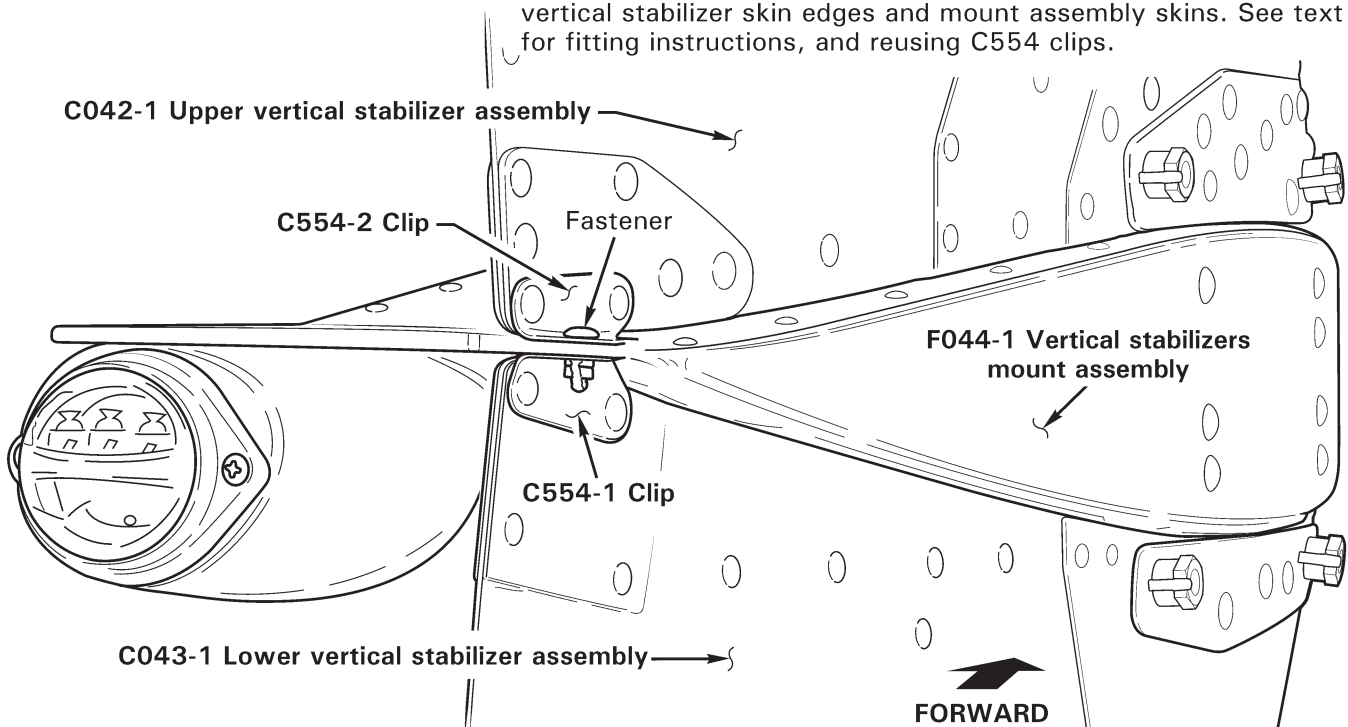
Install hardware securing empennage assembly to tailcone assembly aft bulkhead; select bolt length to meet torque requirements per § 20-30.

If replacing stabilizer(s), verify 0.030–0.120 inch gap between vertical stabilizer skin edges and mount assembly skins. See text for fitting instructions, and reusing C554 clips.

FIGURE 53-7 F004-2 EMPENNAGE ASSEMBLY – TAILCONE ASSEMBLY AFT BULKHEAD

1. Refer to Figure 53-7 or 53-7A. Position empennage assembly on tailcone assembly aft bulkhead.
 - a. **If D301 (empennage ballast; ref. § 8-32) weights will not be installed:** Install (2) NAS6606-47 bolts & associated hardware securing empennage to aft bulkhead. Use (1) or (2) NAS1149F0663P washers under nut as required to meet torque requirements per § 20-30 Part E. Standard torque bolts and palnuts per § 20-32 and torque stripe per Figure 5-1.

1. Refer to Figure 53-7 or 53-7A. Position C043-1 lower vertical stabilizer assembly on empennage assembly. Verify 0.030–0.120 inch gap between vertical stabilizer skin edges and F044-1 vertical stabilizers mount assembly (or C044-1 or -2 horizontal stabilizer, if installed) lower skin. File vertical stabilizer skin edge(s) as required. Conversion coat & prime bare aluminum edges per §§ 20-51 & 20-60.

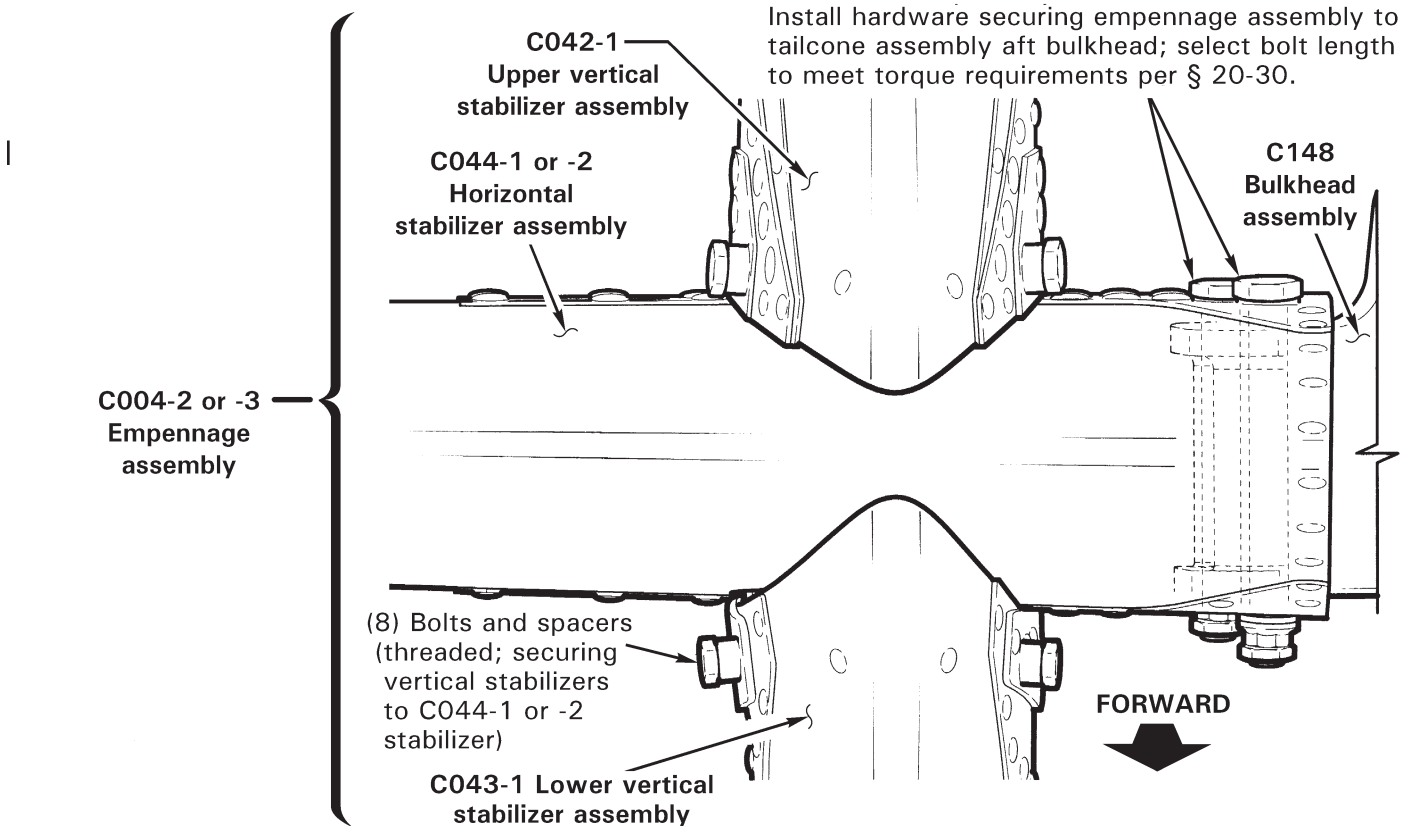
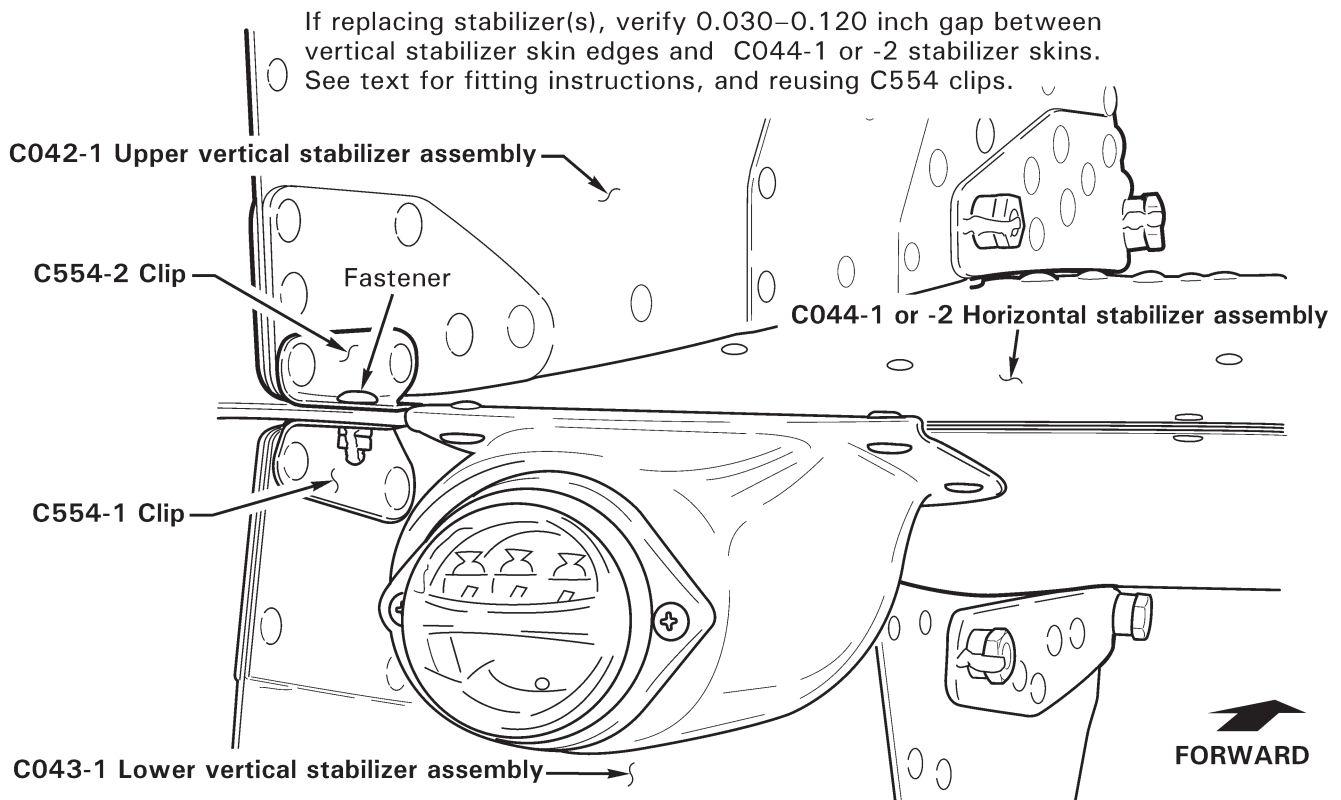
FIGURE 53-7A C004-2 OR C004-3 EMPENNAGE ASSEMBLY – TAILCONE ASSEMBLY AFT BULKHEAD

1. Remove tail rotor guard assembly per § 53-50.
2. As required, remove C050-2 or G950-2 horizontal stabilizer assembly per § 53-80, and tail skid per § 53-90.
3. Refer to Figure 53-7 or 53-7A. Remove fastener securing C554-1 & -2 clips to F044-1 vertical stabilizers mount assembly (or C044-1 or -2 horizontal stabilizer, if installed).
4. Supporting C043-1 lower vertical stabilizer assembly, remove bolts & spacers securing C043-1 stabilizer to mount assembly (or C044-1 or -2 stabilizer), and remove C043-1 stabilizer.
5. If replacing C043-1 stabilizer, C554-1 clip may be reused. Drill out two rivets securing clip to C043-1 stabilizer and remove clip.

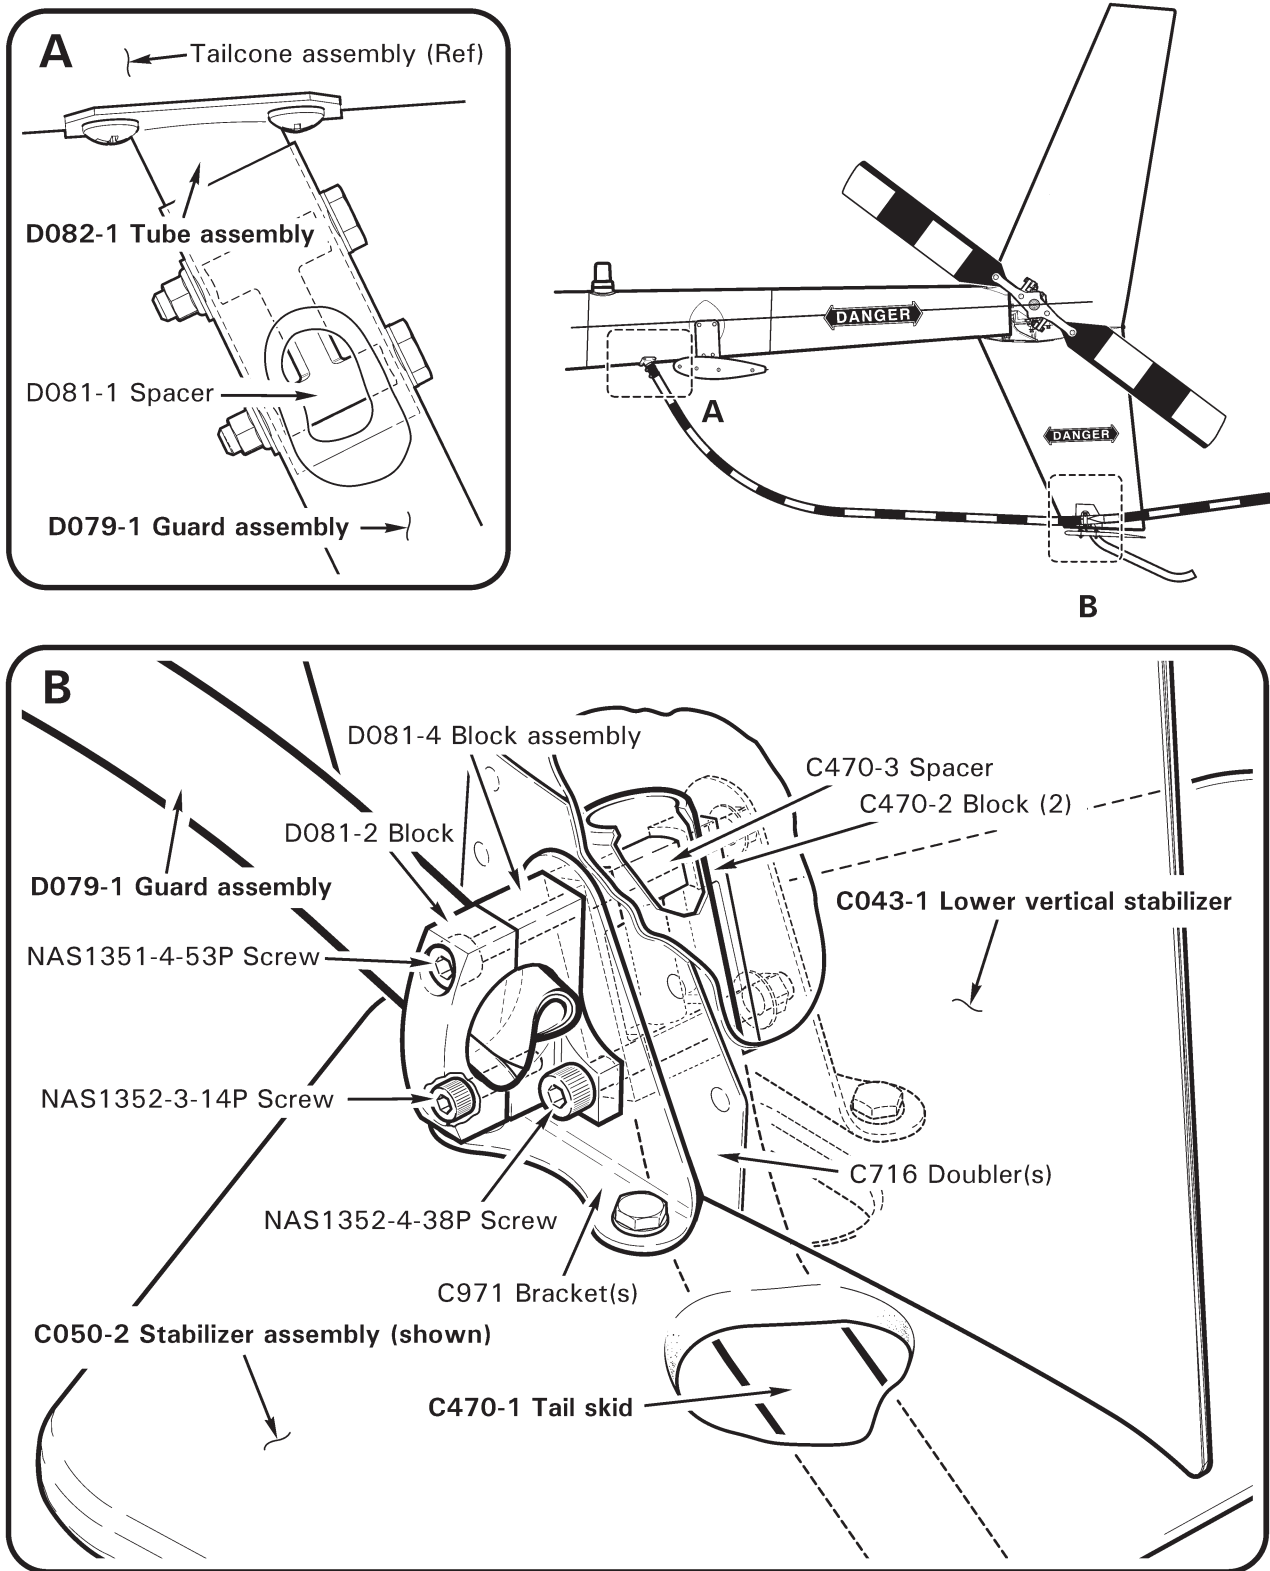
FIGURE 53-8 EMPENNAGE – TAIL ROTOR GUARD

1. Refer to Figure 53-8. Loosen two (forward) fasteners securing D081-2 block and D079-1 guard assembly to C043-1 lower vertical stabilizer.
2. Remove hardware securing guard to D082-1 tube assembly. Slide guard off of tube, then forward through blocks. Remove D081-1 spacer from tube.

1. Refer to Figure 53-8. Loosen two (forward) fasteners securing D081-2 block to C043-1 lower vertical stabilizer, if not previously accomplished. Insert D079-1 guard assembly aft through blocks.
2. Lightly coat retaining hardware and mating surfaces of D082-1 tube assembly and D079-1 guard assembly with § 20-70 approved primer, prior to installation.
3. Install D081-1 spacer inside tube. While wet with primer, slide guard onto tube and install hardware. Standard torque bolts per § 20-32, and torque stripe per Figure 5-1. Seal around end of guard with primer after assembly.
4. Verify D081 blocks clamp guard sleeve. For proper guard-to-stabilizer clamping, first standard torque (forward, top) NAS1351-4-53P screw and associate hardware per § 20-32, then special torque (forward, bottom) NAS1352-3-14P screw and associate hardware per § 20-33. Torque stripe fasteners per Figure 5-1.
