R44 SERVICE LETTER SL-79

R66 SERVICE LETTER SL-37

SUBJECT: Main Rotor Blade Unpainted Leading Edge Care

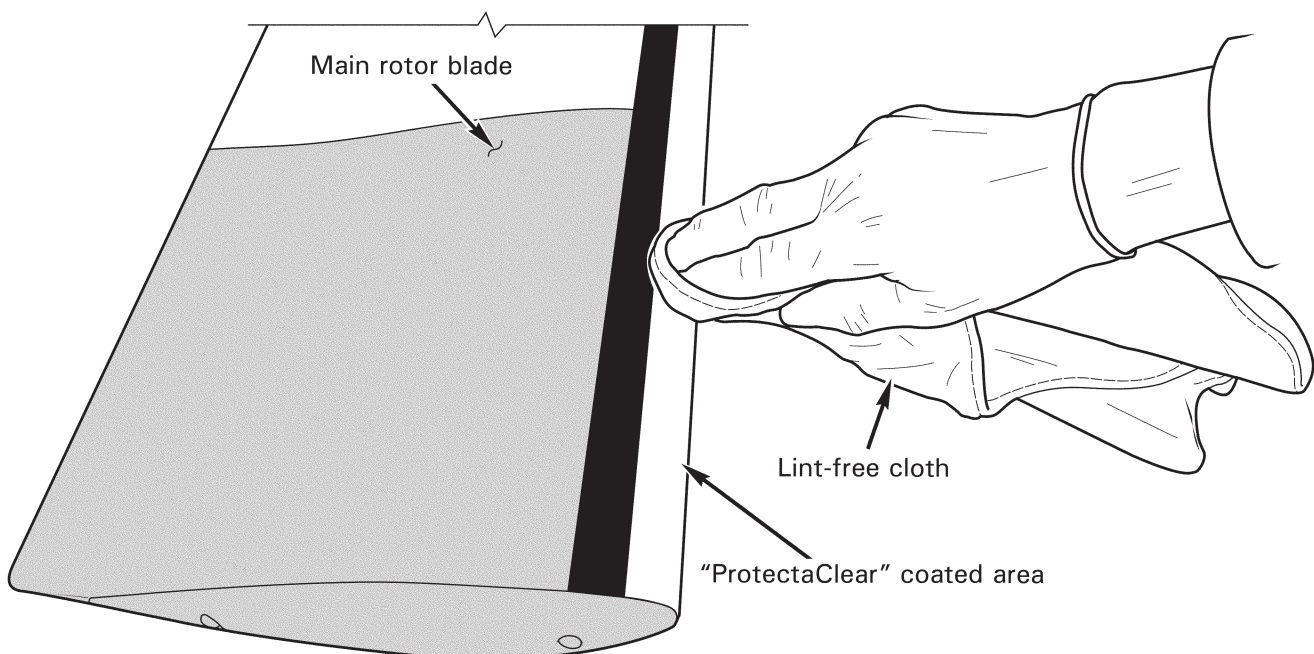
BACKGROUND: Outboard, unpainted leading edges of new main rotor blades are coated with ProtectaClear (www.everbritecoatings.com). Though the leading edge is stainless-steel, corrosive environments may cosmetically affect the unpainted leading edge after ProtectaClear erodes. ProtectaClear may be renewed at operator's discretion per the following procedure.

1. Remove any oxidation from unpainted leading edges using maroon-colored Scotch-Brite™ pad (3M General Purpose Hand Pad 7447).
2. Clean surface to be coated using mild soap and water (acetone may be used as necessary; do not use MEK or alcohol). Water-rinse immediately and allow to dry.
3. Wearing nitrile glove, apply a coat ProtectaClear using lint-free cloth and allow to dry (approximately one hour).
4. A second coat may be applied for additional protection.
